## Annular Fan hub failure

### Fan type – Multiwing 8 blade aluminium cast hub

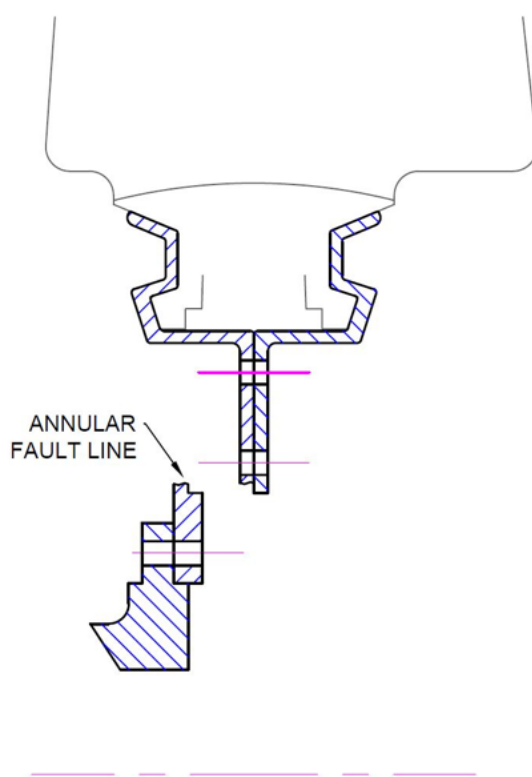
FAULT LINE AT  
THINNEST POINT

1. The initial failure occurred at the root of the male shoulder of the mating surfaces of the two hub halves. Any sharp internal edge is a stress concentration point, both in use and also from the casting process.

2. The material flange thickness was 3.3mm. This is the thinnest I have seen, with equivalent hubs ranging from 3.5 to 4mm thick.
3. The male boss is only 140mm dia compared with the 12 blade hub at closer to 190mm. this increases the torque loading at that smaller diameter and also reduces the circumference cross sectional area at the weak fault line

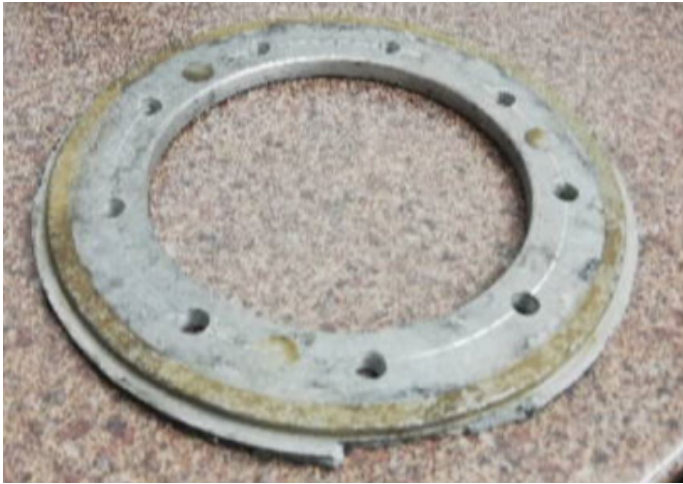
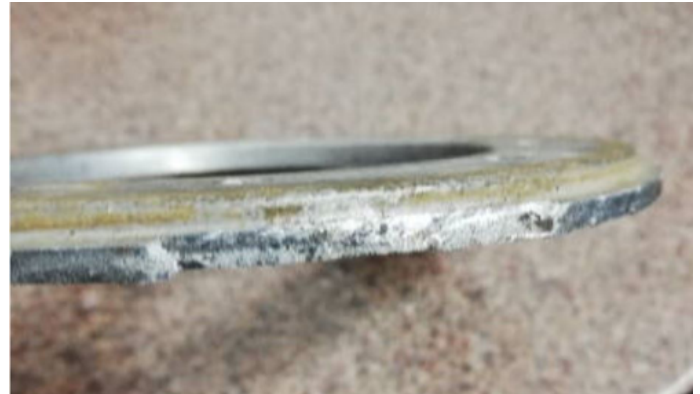
On inspection of the one failed hub available, there is a premature crack around 60mm long showing signs of typical oscillation induced fatigue. Once this had become significantly large enough to overstress the cast material, an annular brittle fracture would soon follow. This can be seen in the coarse granular surface of the break. Unfortunately this kind of fault is almost instantaneous, and no prior evidence or tell tail signs of imminent failure can be seen beforehand

Just as important to consider is the manufacturing process and the unavoidable characteristics of the cast material properties. High precision die cast products suffer from micro porosity due to the quick cooling of the metal causing contraction. This can become particularly prevalent in areas of sudden differing thickness as the rate of cooling can be uneven. The male boss step is such an area of material thickness change. This can cause a ring of porosity which acts like a perforation line. Evidence of such porosity can be seen in the photos
